Manhole Inspection Summary

Manhole # S41CC_070MH

Location Address: **1505 ashland ave**

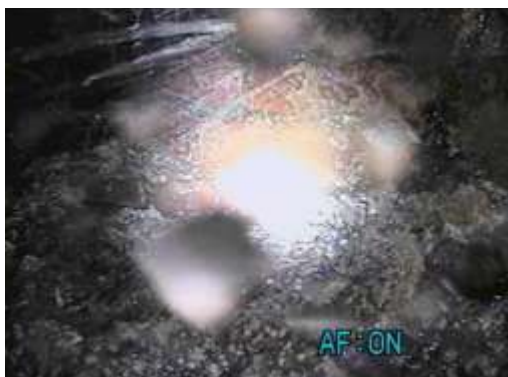
Defect 5

Condition: ☐ Sound ☐ Cracked ☐ Root Intrusion ☐ Deteriorated ☐ Leaks ☒ **Debris**

bench debris

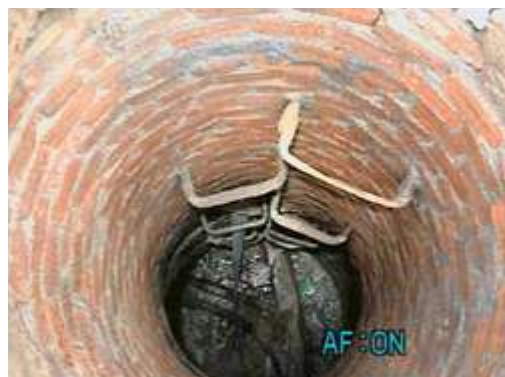
Defect 4

Count: **10** Missing: **1** ☒ **Corroded**

missing/corroded steps; surcharge evidence

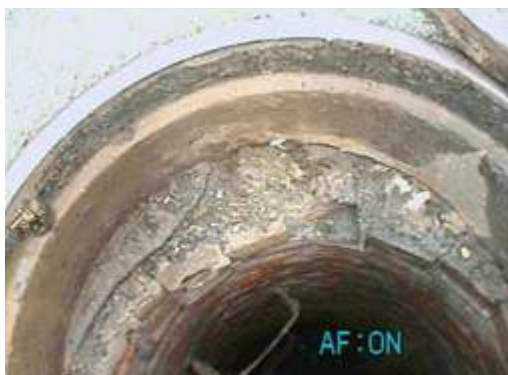
Defect 3

Offset: **5** (in.)

offset

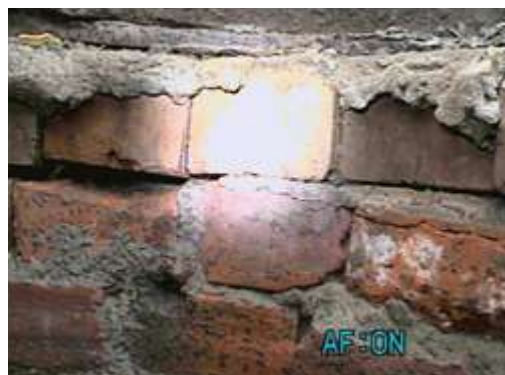
Defect 2

Condition: ☐ Sound ☒ **Cracked** ☐ Root Intrusion ☒ **Loose Brick** ☒ **Deteriorated**

chimney deteriorated with cracked & loose brick

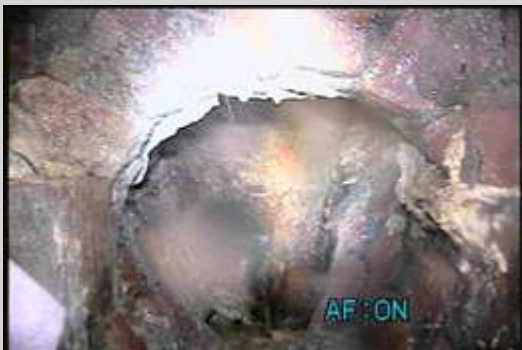
6 O'Clock Inflow

Deposits: ☐ None ☐ Mud ☒ **Sludgy** ☐ Debris ☐ Grease

Silt Depth: 7 (in.) Deposits Extent: **Medium**
